PLSS Monument Preservation Sheet

U T 2 6 0 0 5 0 S 0 2 1 0 E 0 1 0 3 1 0 0

Uintah County

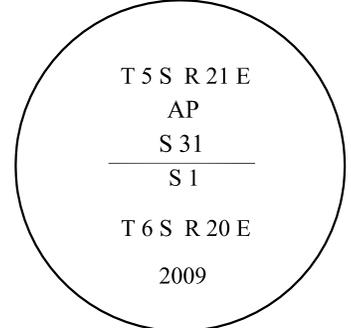
Monument Inscription

Show rotation of stampings/markings relative to North and describe briefly

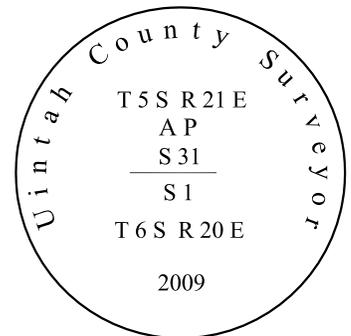
2009 Uintah County Surveyor aluminum cap on 3/4" rebar with 3.5' Dia. x 1.5' high mound of stones around the cap.

County Surveyor Aluminum Cap
on 3/4" Rebar

At the Angle Point we found a loosely set stone with AP chiseled on north face. Stone measures 24" x 14" x 14" (bottom 12" of stone leached of color from being below grade) and was surrounded by a mound of stones 42" in diameter by 18" high. We removed the set stone and replaced it with a 3/4" rebar fitted with a 2.5" 2009 Uintah County Surveyor Aluminum Cap, marked for the Angle Point. We placed the stone along the southern edge of the cap with markings to north and re-built the pile of stones around cap.
